Report No. 0703-19312

**METALLURGICAL EVALUATION
OF TWO FRICTION WELDED
GRADE 1045 STEEL BARS**

March 29, 2007

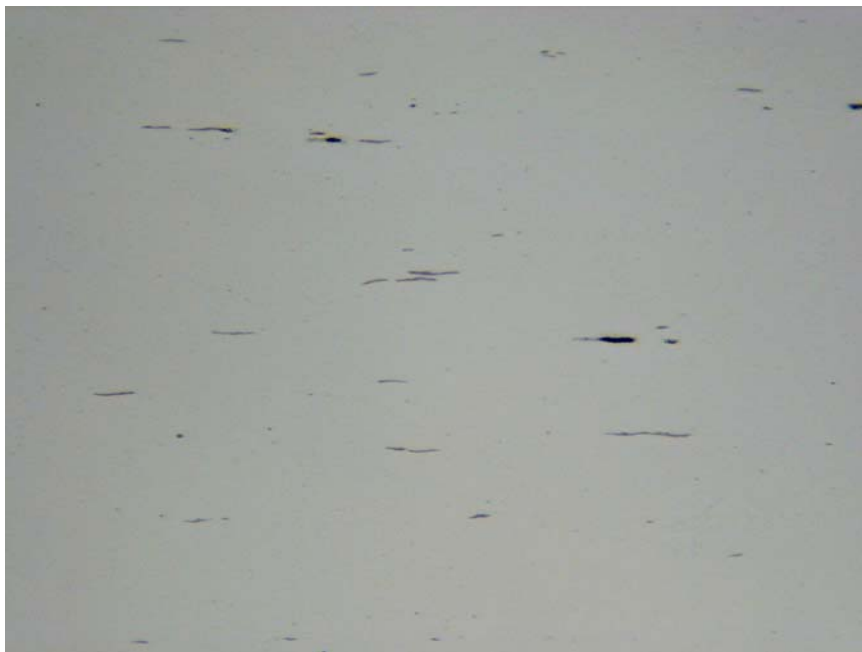
Fig. 4 - Cross section through the small diameter bar, showing stringers of manganese sulfide inclusions. Unetched. (100X)

A metallographic specimen was extracted from Sample A at the location shown in Figure 1. Examination of the base metals prior to etching revealed that both the small diameter and large diameter bars exhibited scattered manganese sulfide stringers, as shown in Figures 4 and 5, respectively. The manganese sulfide stringers are typical for a Grade 1045 steel. A cross section through the weld from the large bar base metal to the small bar base metal is shown progressively in Figures 6 to 9. The microstructures at the large bar base metal, heat affected zone for the large bar, weld region, heat affected zone for the small bar, and the small bar base metal are shown in Figures 10 through 14, respectively. The base metals of both bars consist of pearlite and ferrite, which is typical for a hot rolled medium carbon steel. The heat affected zones exhibit a finer structure of pearlite and ferrite. The fusion zone of the weld exhibits fine pearlite and Widmanstätten ferrite. It should be noted that the near surface region of the small diameter bar exhibited evidence of decarburization, which is shown in Figure 15.

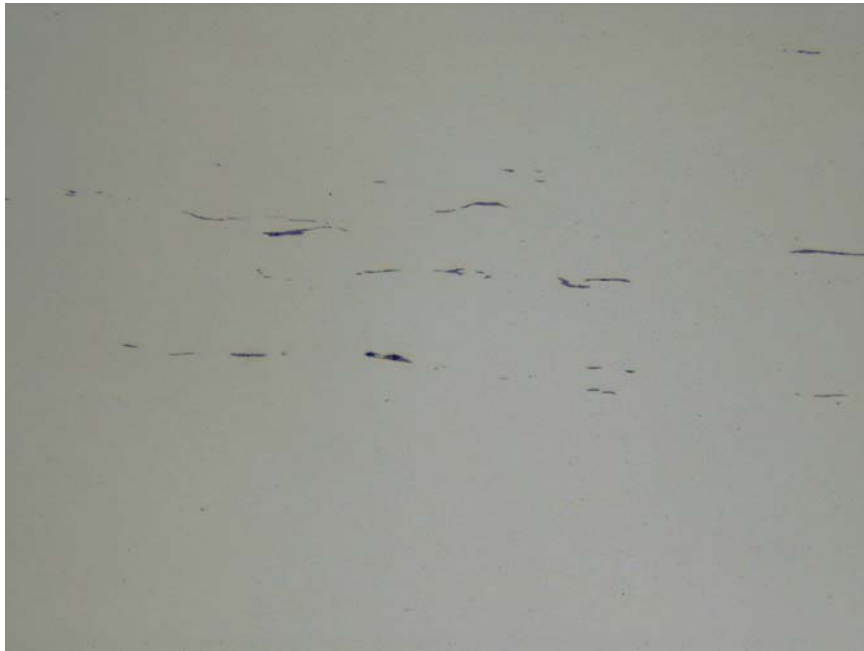
Fig. 5 - Cross section through the large diameter bar, showing stringers of manganese sulfide inclusions. Unetched. (100X)

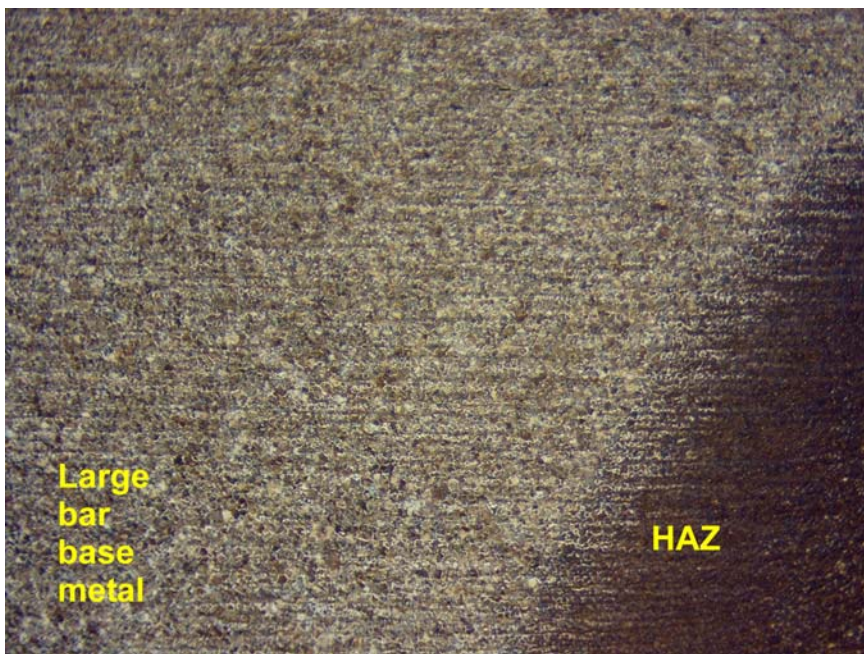
Fig. 6 - Cross section through the interface between the base metal of the large diameter bar and the heat affected zone of the large bar. 2% Nital. (12X)

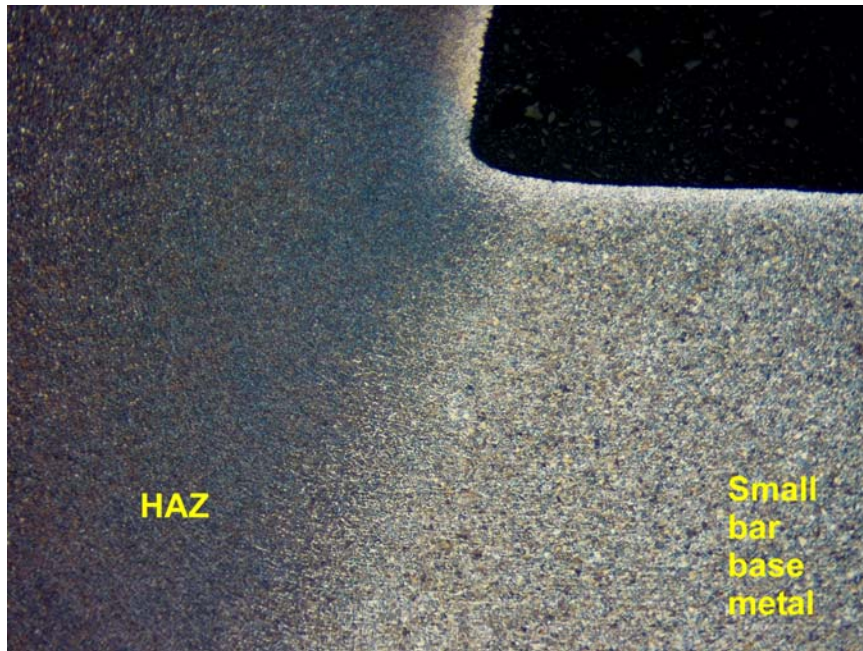
Fig. 9 - Cross section through the interface between the heat affected zone of the small bar and the small bar base metal. 2% Nital. (12X)
